REMEDICATION OF LANDSLIDES ON THE R1 EXPRESSWAY IN SLOVAKIA

František Baliak¹, Martin Brček², Viktor Janták³, Peter Mušec⁴

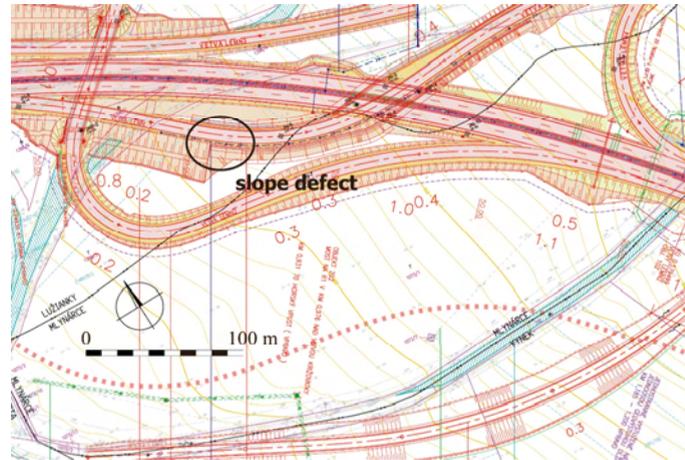
Fig.1 Situation at SO 102 Lehotka Intersection

Slope defect occurred on the right-side of the cut slope of LEMN1 branch built as a part of SO 102 object, Lehota intersection. It is an access branch under the SO 202 bridge object, in direction to Nitra. In affected area, the route is led in cut with slopes decline of 1:2.5 and the excavation is partially absorbed by the retaining walls (fig. 1).

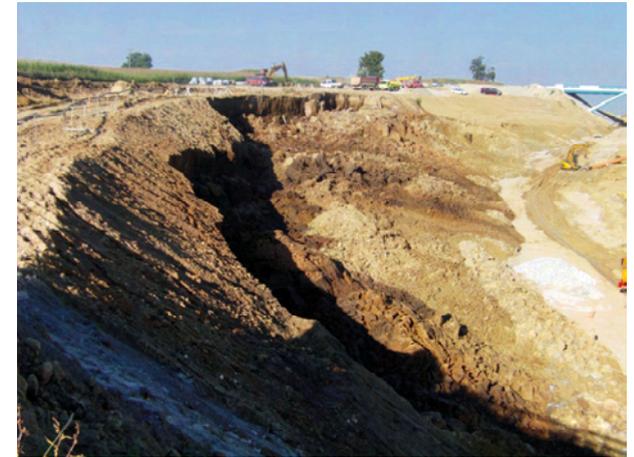
In the affected area, the road is led in cut, in depth of 5 – 8 m. According to the survey works (JN-6 and JN-7 holes) of detailed engineering and geological survey, cover post-tertiary floury soils sediments with characteristics of clay with medium plasticity (F6 Cl), infiltrated by inter-layers of clay with high plasticity (F8 CH) and of solid to firm consistency were found in the area. Neogénne was verified in depth from 7.20 m b.t. to 9.80 m b.t., again in clay stage (F6 CI) with concretions of CaCO₃. Forming of this slide was invoked by the favourable geologic and tectonic structure for slope motions formation, specifically by the presence of transferring polygenetic floury soils, significantly damped and frozen lying on neogénne pre-consolidated, volume-unstable clays after the long-term influence of precipitations in summer months of 07 – 08/2010.

In terms of slope motions classification (Nemčok et al., 1974) it is a frontal slide along the rotational and planar surface of sliding, at time of occurrence an active one currently stabilized one (fig. 2). The estimated surface of sliding was in depth of about 8 m b.t.

Fig.2 Disjunct wall of slope defect (09/2010)

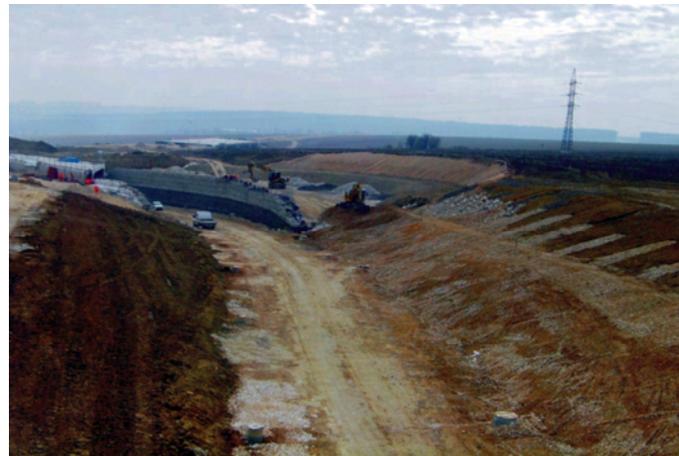
Fig.3 Supercharging of the slope and drainage edges (03/2011)

The Contractor started the redevelopment of the branch cut slope landslide on the right side in November 2010. The proposal for stabilization and redevelopment measures were elaborated as a combination of improved over limed soil, geotextile and quarry stone application. After soil unloading, the stone with fraction of 32 – 125 mm was laid in the vacant area, at the slope foot with fraction over 125 mm. Then backfills and shape modifications were implemented. A full-area drain was built for consistent dewatering and drainage ditches with inter-axial

distance of 6m under the upper edge of the excavation. The drains are built with gravel aggregate with fraction of 32 – 63 mm and 32 – 125 mm (fig. 3).

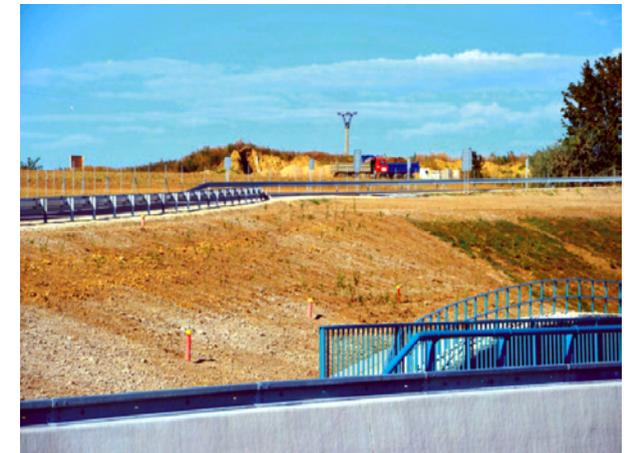
Fig.4 Monitoring system (09/2011)

After finishing the terrain modifications and dewatering measures, a monitoring system of monitoring holes (INK-1, INK-1', INK-2 and INK-2' into the depth of 21 m), which are part of the monitoring object system of long-term geo-technical monitoring, was built in the affected area (fig. 4).

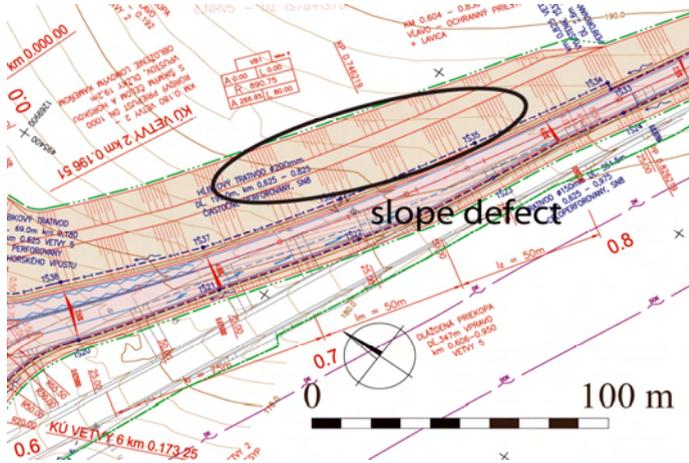
Fig.5 Situation of SO 102 Selenec Intersection, branch 5

The landslide occurred during the implementation of the left-sided cut slope of branch 5 SO 102 „Selenec Intersection“ in km 0.600 – 0.800, in chainage 0.300 of the route SO 101 (fig. 5). At the time of occurrence it was several fragmental slides with total width up to 250 m and length in the direction of motion up to 50 m.

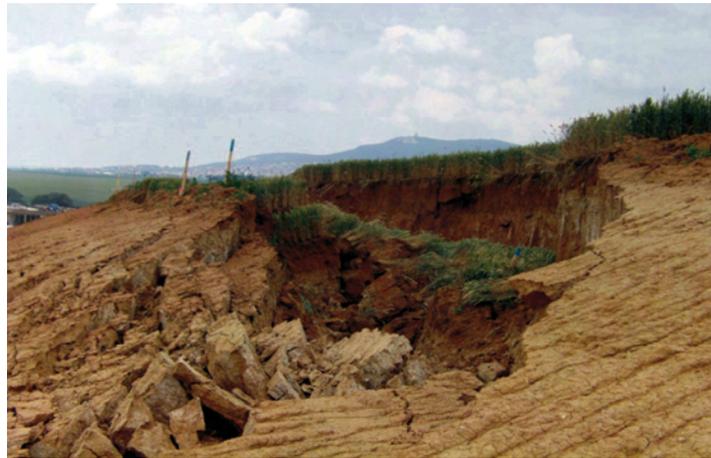
The depth of the slide area was up to 2.50 m. In terms of slope motions classification (Nemčok et al., 1974) it is a frontal landslide along the rotational – planar to planar surface of sliding, at time of occurrence active, currently stabilized (fig. 6). The area affected by the loss of stability is from the engineering and geological perspective formed by post-tertiary regolith at the interface with polygenetic complex of cohesive soils with neogénne Pontian sediments. As the intersection project was changed during the construction in this area, there is no monitoring hole in the affected area. The closest monitoring hole is JS-13, which proved the presence of post-tertiary soils (silts and clays) down to the depth of 1.50 m, under which neogénne sediments occur in clay development transiting into sands in the depth of 8.50 m. The neogénne sediments emerge even up at the surface at the point of slope defect.

Fig.6 Separated wall– overlapping the construction site border

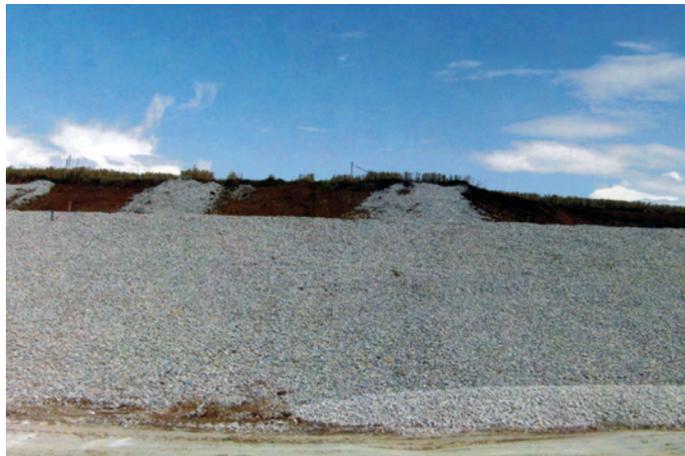
Fig.7 Drainage and slope loading

The stabilization process of the landslide was extensive. Firstly, a deep left-sided drain was built along the defected section, the slid soil was excavated and transferred step by step behind the sliding area, then the cross dewatering and stabilizing counterforts were implemented under the line of sliding level within the axial distance of max.10 m and the excavated soil was replaced with quarry stone with 32 – 64 fraction. The slope gradient above the dive was decreased to 1:4 (fig. 7). Then the whole area was covered with mould. The slope is currently stabilized. Slope monitoring is performed by visual inspections and evaluation of the only inclinometer borehole - I6, which was implemented to the depth of 15 m b.t. From the obtained shifts values (up to max. 9 mm) it can be stated these were formed in connection with the inclinometer hole assembly (fig. 8).

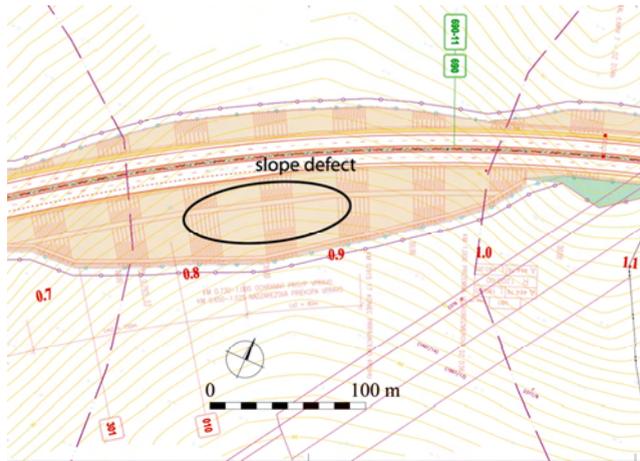
Fig.9 SO 101 R1 route

The landslide was activated on right-side of the cut slope of SO 101 in km 0.7 – 1.0 (fig. 9). The slide was up to 160 m wide and length was up to 60 m in the direction of motion. The depth of sliding surface was up to 9 – 10 m. In terms of slope motions

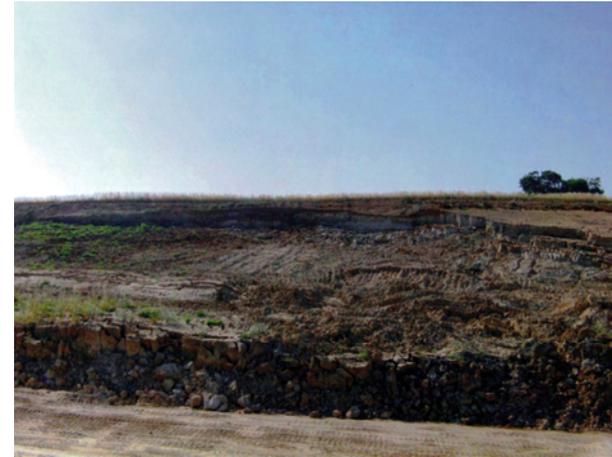
Fig.10 Head of the slide

classification (Nemčok et al., 1974) it is frontal slide along the rotational and planar surface of sliding, active at time of occurrence, at the moment stabilized (fig. 10).

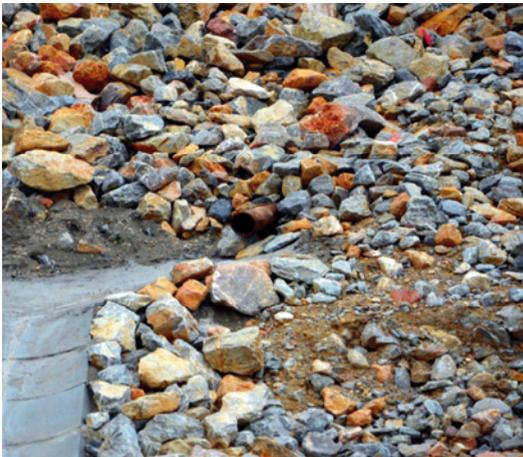
Fig.11 System of dewatering holes

In the first phase, the unloading of the slid soil was executed as a redevelopment measure, than the cross drainage webs were built ending into the longitudinal drainage. The slope was loaded by quarry stone and the upper slope part above the berm was modified according to 1:2.75 incline (fig. 12). After finishing the redevelopment works the Contractor built 3 vertical inclinometer holes. The I2a and I2b inclinometers of 15 m depth did not show any significant motion (<3mm). The measuring of 11 inclinometer in 20 m depth (the crest of the slope) showed the maximum motion 13 – 20 mm. Besides measuring the shifts in inclinometer holes, there is a necessary visual monitoring of possible morphological changes on the cut slope performed. In the summer months of 2011, a fan-shaped system of horizontal-deep dewatering holes was built in order to eliminate water accumulation in the cut body and other potential symptoms of instability (fig. 11).

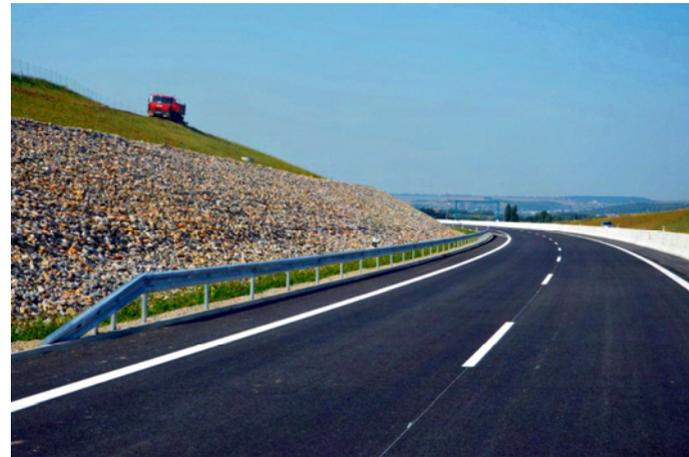
Fig.12 Slope loading and final modifications

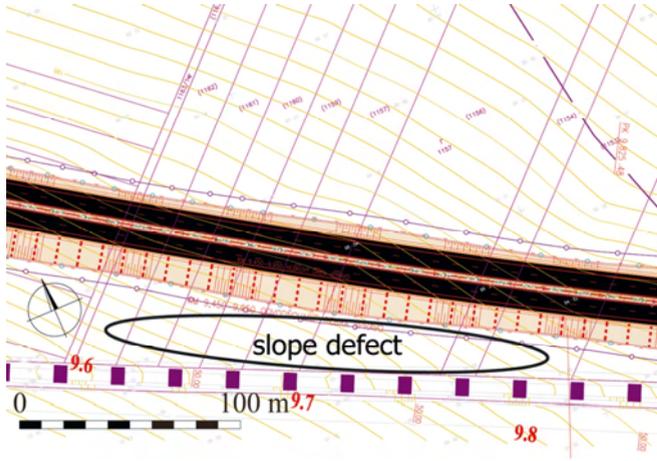
Fig.13 SO 101 R1 route

The slide was activated on right-side of cut slope of SO 101 in km 9.6 – 9.8. Its width reached 200 m. Depth of the surface of sliding was down to 10 m (fig. 13). According to the slope motions classification (Nemčok et al., 1974) it is a frontal slide along the rotational and planar surface of sliding. From the activity point of view, it was an active slide at the time of occurrence, currently stabilized (fig. 14). Its formation or the re-activation of the slide was influenced by the formation of slide deluvial deposit already mentioned during the project preparation phase in JS-148 and JS-149 holes and which were formed during the slopes sliding in the past. Neogénne is mostly in clay stage sporadically with sand layers.

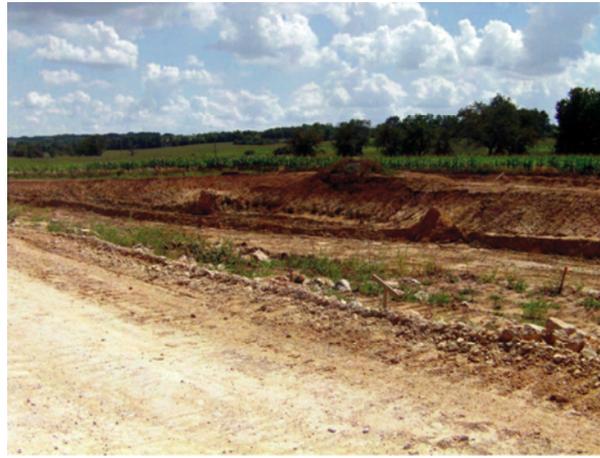
Fig.14 Slide at the right side cut

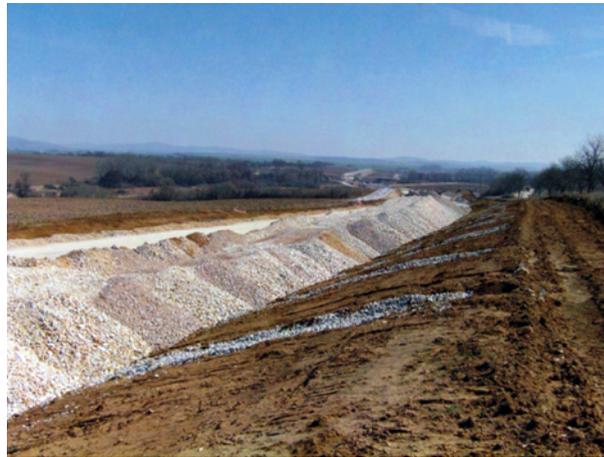
Fig.15 Redevelopment – drainage webs

The stabilization of the slide consisted of unloading of the slid material and implementation of drainage measures including drainage webs building into about 2 m depth, then building of surface drain. The slopes were definitely sloped in 1: 2.25 incline down to the border of permanent occupation of the construction (fig. 15).

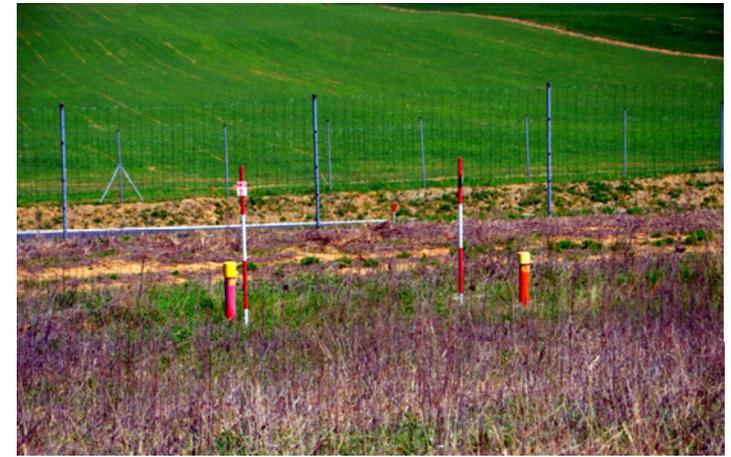
which there were minor motions up to 1 mm recorded. In km 9.800 there is an inclinometer hole -I5 where maximum shifts of 100 mm along the sliding surface were recorded in depth of 3 m as of August 23, 2011. Besides shifts monitoring in the inclinometer holes, regular visual monitoring of morphological changes on slope is executed (fig. 16).

Fig.16 Monitoring system–inclinometer holes

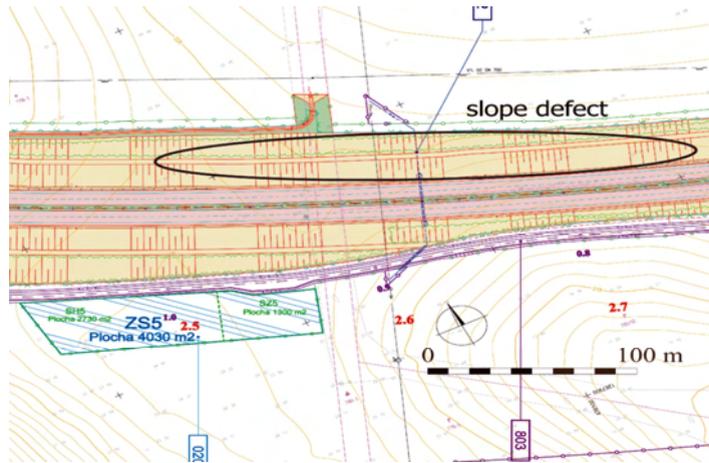
Fig.17 SO 101 R1 route

On SO 101 construction in km 2.300 – 3.100 there were multiple slides activated on left side of the cut slope, while the most affected area was in km 2.450 – 2.650 (fig. 17). The width of sliding area was in total up to 800 m and the length in the direction of the motion up to 60 m. In accordance with the slope motions classification (Nemčok et al., 1974) this is a frontal sliding area along the rotational and planar surfaces of sliding of the depth up to 8 m. From the activity point of view these were active slides, currently they are considered as potential up to

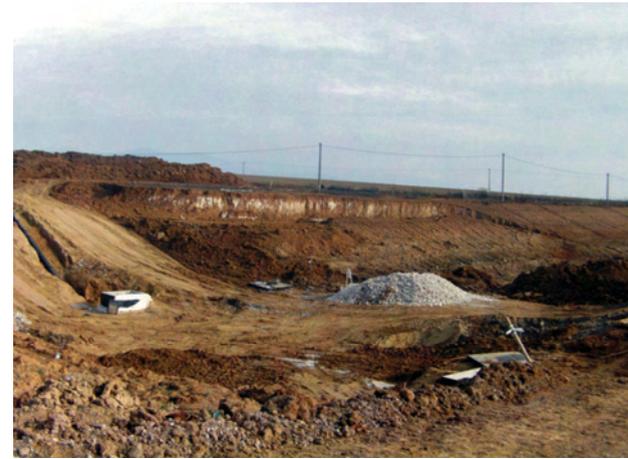
stabilized. From the engineering and geological conditions perspective the slides were activated in area with the occurrence of post-tertiary regolith of fine-grained soils down to depth of 4.60 m on the neogénne sediments mostly in clay or less sandy stage. The geological conditions in the area of the slope defect were in the phase of monitoring verified by the JB-72 hole (fig. 18).

Fig.18 Slope defect in left side cut

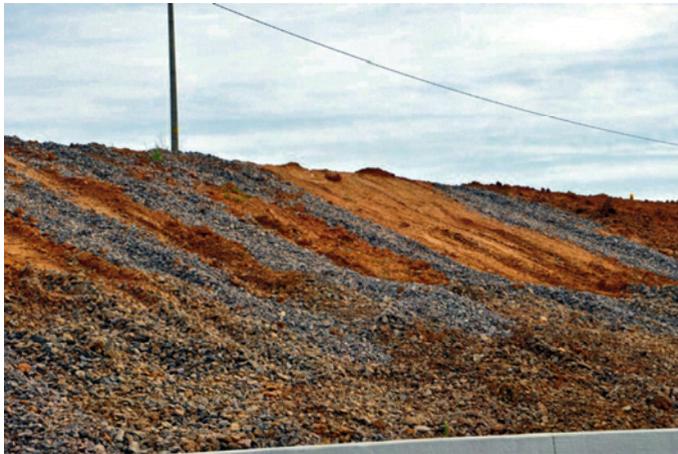
Fig.19 Drainage webs and surface drainage

An extensive stabilization was performed on the slope, which consisted of unload of the sliding soils along the surface of sliding, slope dewatering by the system of cross dewatering webs and drainage filtration backfill of 63/125 mm fraction with shear castellation and slope additional fill-up with berm creation at the level of about 3.0 m from the cut top. The slope was modified within the incline of 1:1.25. The webs were implemented down to the depth of 2.5 – 3 m, width down to 1 m and above the cut a circuit drain was built (fig. 19). Based on the fact that performed stabilizing measures were not sufficient, the improvement of the slope stability was performed by the additional slope dewatering using the siphon drains. Slope redevelopment implementation by mentioned technology is a subject to other report. Within the monitoring there were three vertical inclinometer points embedded (IV3, IV4, IV5) on the level of slope berm (fig. 20), the system of geodetic control points and monitoring hole for the subsurface water level monitoring. The monitoring at the mentioned points is currently still in progress. Currently there were only minimal excess deformations (up to 2 mm) recorded.

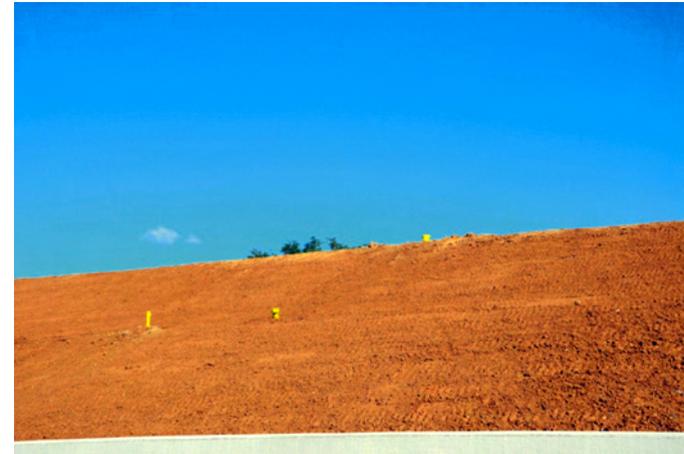
Fig.20 Inclinometric and piezometric holes
