**GPR DETECTION OF VOIDS UNDER CONCRETE COMMUNICATIONS (CASE STUDY)  
DETEKCE VOLNÝCH PROSTOR POD BETONOVÝMI KOMUNIKACEMI POMOCÍ GPR  
(PŘÍPADOVÁ STUDIE)**

**Abstract**

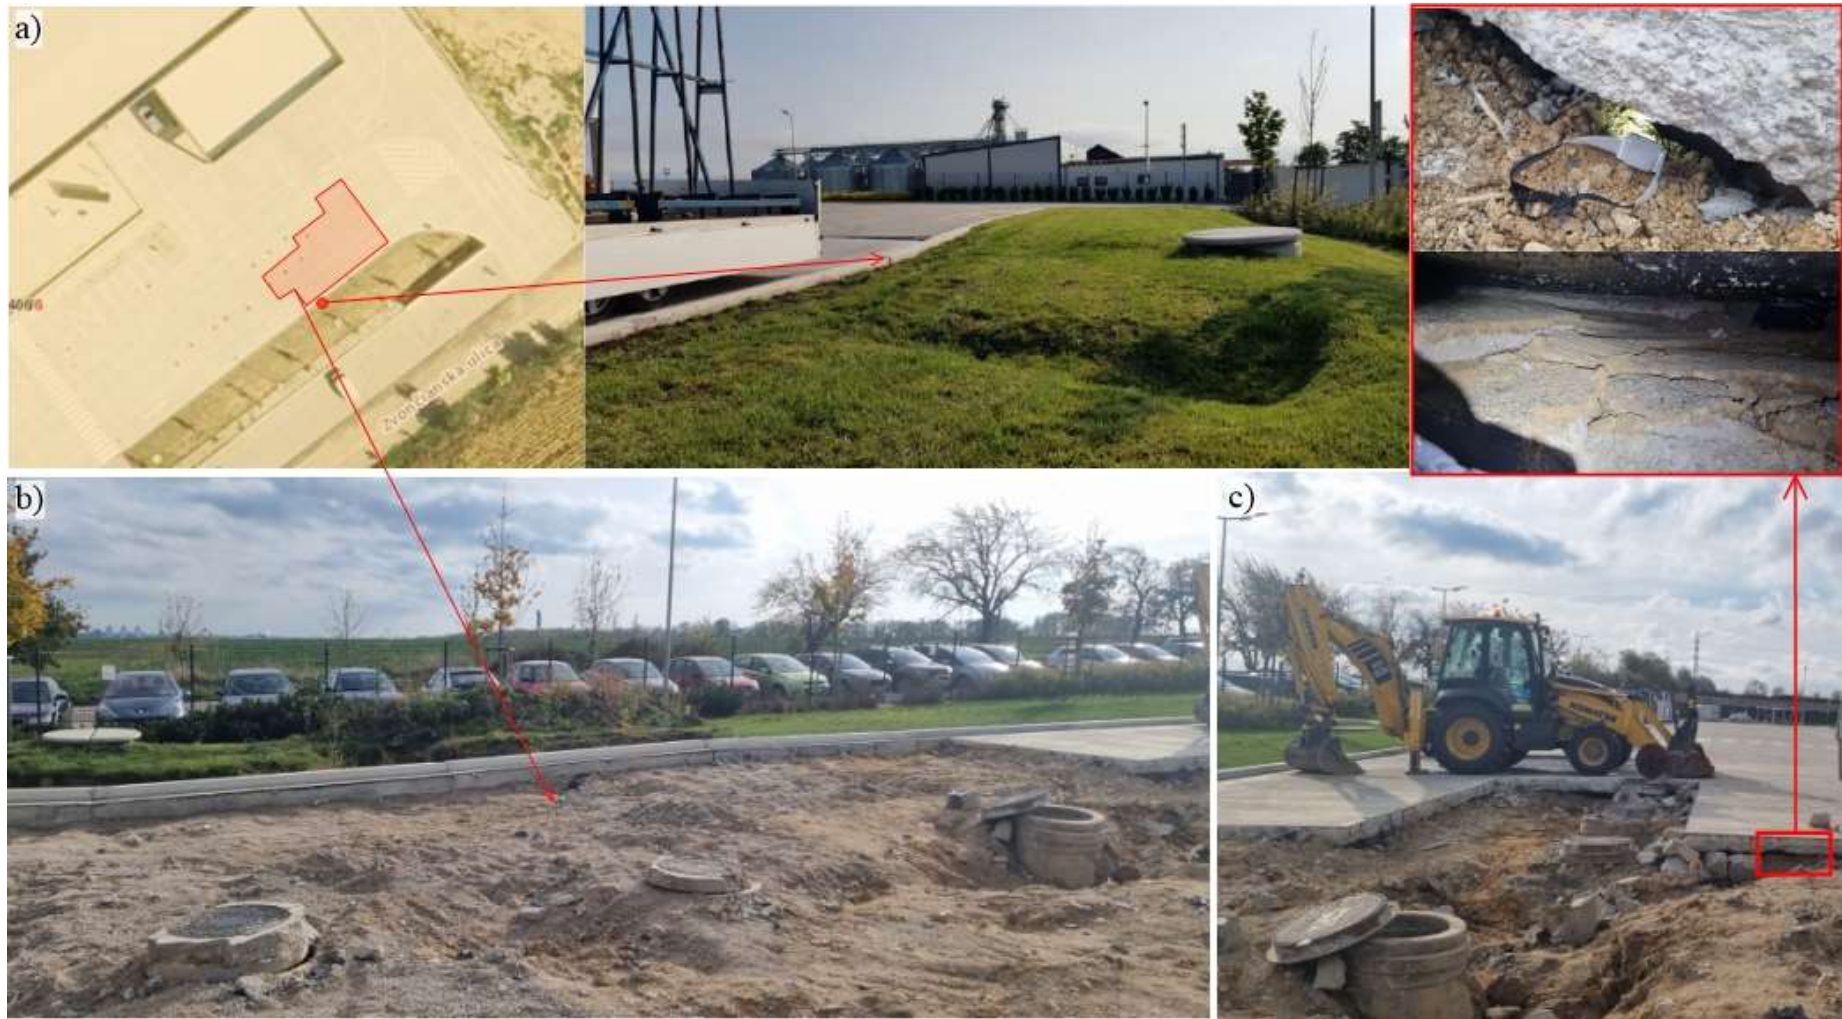
The first study is from the area of the Trnava Hills and is an example of the direct manifestation of the presence of cavities on the radargram. These cavities were formed under the concrete communications around the production hall built on the fringe of the village of Šelpice (Fig. 1). After heavy rainfall, repeated inbreaks of the curb and the drainage channel (Fig. 2a right) occurred in the diagnosed area above the drainage pipe leading from the retention tanks, located under the surface of parking lot, to the infiltration well. The removal of the parking lot concrete slabs at the damaged site showed the presence of extensive voids between the concrete cover and the underlying layer in the vicinity of the retention tanks (Fig. 2b) as well as their continuation under the uncovered parts of the parking area (Fig. 2c).

The task of the GPR measurements was to determine the extent and expansion of cavities in the area. However, for this it was necessary to know the cause of their formation. A more detailed study of the available materials (mainly exploratory boreholes carried out in this area) showed that the voids between the concrete panels and the underlying layers were created as a result of loess collapsibility under the underlying layers of the diagnosed building. The diagnosed areas of the hall complex in Šelpice are located in the Podunajská nížina (Danubian lowland), in the Trnavská pahorkatina (Trnava Upland) part. From a geological point of view, the pre-Neogene basement consists of crystalline rocks, on which Neogene marine sediments (reaching a thickness of up to 1000 m) and lacustrine-fluvial sediments are lying. However, from the point of view of the solved problem, Quaternary sediments are mainly interesting. In addition to fluvial-alluvial sediments linked to valley alluvial streams, large accumulations of loess are characteristic for the Trnava Upland area. These were also confirmed in boreholes (Fig. 3) realized during the engineering geological survey (Pavlech, 2018) before the start of construction. Based on the coefficient of collapsibility ( $I_{mp}$ ) determined on the samples from the wells, these loess horizons were classified as collapsible ( $I_{mp} > 1\%$ ), in one case even on the border of very collapsible ( $I_{mp} > 3\%$ ).

**Fig. 2** *Faults and voids in the front part of the area in Šelpice with their marked location (localization basis: zbgis, ÚGKK SR, Bratislava): a) curb and drainage channel collapse, b) voids between the concrete cover and the bed layer under the removed concrete slabs in the vicinity of retention tanks, c) continuation of the failure under the uncovered parts of the parking area with a detail of the cavity under the concrete slab*

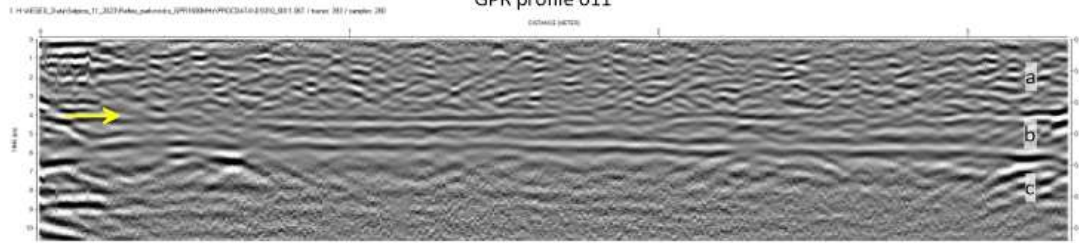
GPR profile 011

Measurements from the first stage of the survey did not show the presence of voids or other significant deformations of the basement at greater depths (up to 1.6 m with a 450 MHz antenna, up to 12 m with a 160 MHz antenna), except in the area where the retention tanks are installed. On the radargrams measured in their vicinity with a 450 MHz antenna (Fig. 7), when compared with the recording from other parts of the measured area, the environment here is inhomogeneous and that the return embankment in these places is not consolidated. The

**Fig. 7: Examples of processed radargrams measured by the 450 MHz antenna in Šelpice during the first stage**

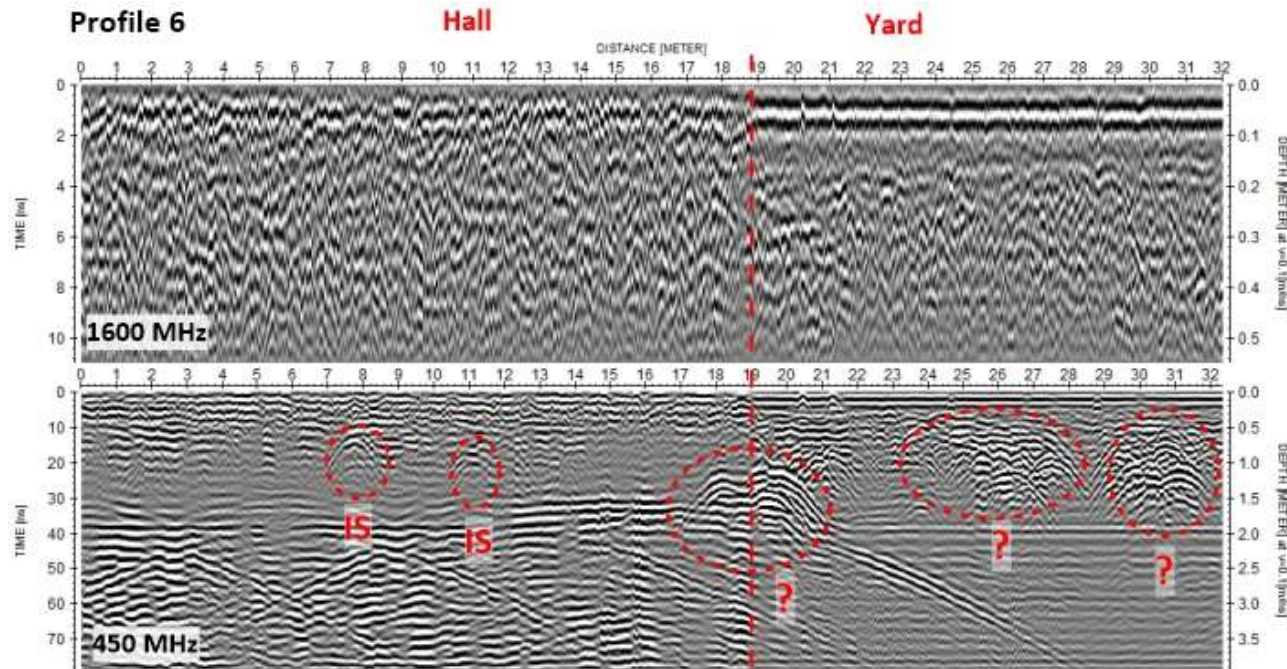
On the radargrams conducted outside the hall, the presence of engineering networks and older excavations was detected, and the original terrain is probably located from a depth of 2 m (Fig. 12).

*Fig. 12: Radargrams from measurement with 1600 MHz and 450 MHz antenna in Malacky - profile 6. The radargram from the 1600 MHz antenna shows sections with the presence of utility networks (IS) and older excavations (?)*
