**THE CONTRIBUTION OF GEOPHYSICS TO THE PREPARATION OF ROAD AND RAILWAY
TUNNEL CONSTRUCTION IN THE AREA OF VÁCLAV HAVEL AIRPORT (RUZYNĚ)**

*Jaroslav Bárta¹, Tomáš Belov¹, Josef Buneš¹, Kateřina Dvořáková¹, Peter Hurbánek², Jaroslav Jirků¹,
Daniel Reif³, Jaroslav Reif³*

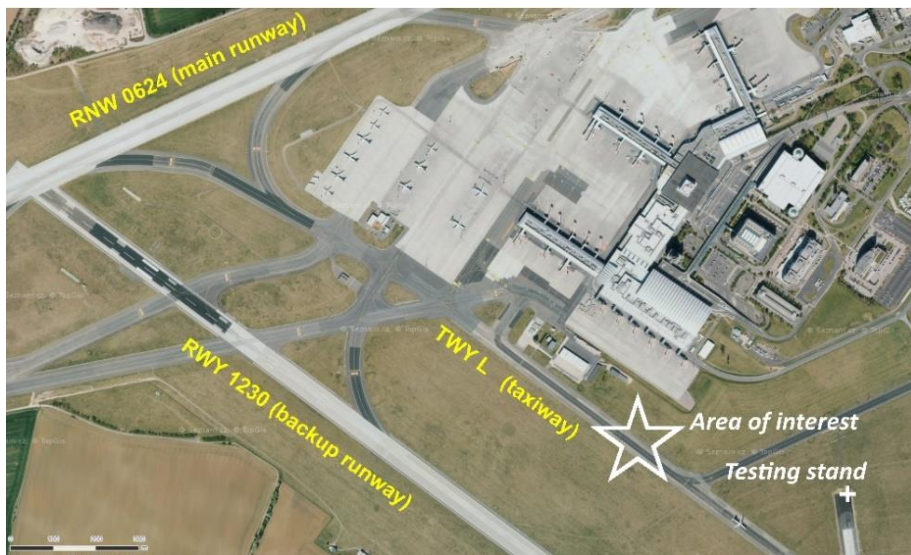
Fig. 1 The map with the area of interest

The area of geological investigation is adjacent to the southeast part of the Terminal 3 (Vaclav Havel Airport). The area of interest is crossed by the taxiway TWY L. See Fig. 1. The Fig. 2 shows the detailed scheme with the projected tunnels, bore holes and the stations for observation of stray (parasitic) currents (ST 1, 2, 3 and 4).

The supplementary measurements was accomplished on the testing stand (see the map on the Fig. 1). The detailed arrangement of the geophysical profiles and testing field works are showed on the Fig 6.

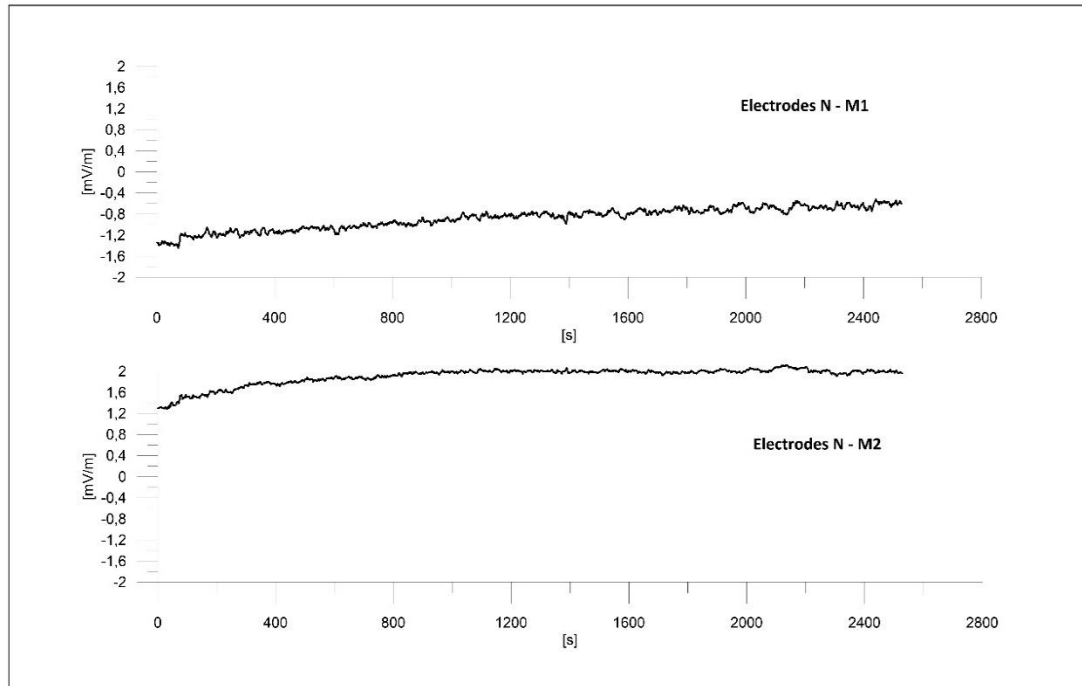
Fig. 3 *The graphs of differences between electrodes N-M1 and N-M2*

On Fig. 3 are presented as example the graphs of differences between potentials of electrodes N – M1 and N – M2.

The area of interest was in general classified in the corrosion level IV in the sense of ČSN 03 8372, see Tab.1. The reason for this conclusion is in principle the result of measurements at the ST4 station, which detected the presence of intense stray currents that can spread further into the projected tunnel structures. According to Technical Instruction TP 124 of the Ministry of Transport of the Czech Republic, it is also level 4. For the situation in the investigated area, it should be noted that the territory is strongly influenced by an unspecified electromagnetic field and that the electromagnetic component 50 Hz is also part of stray currents.

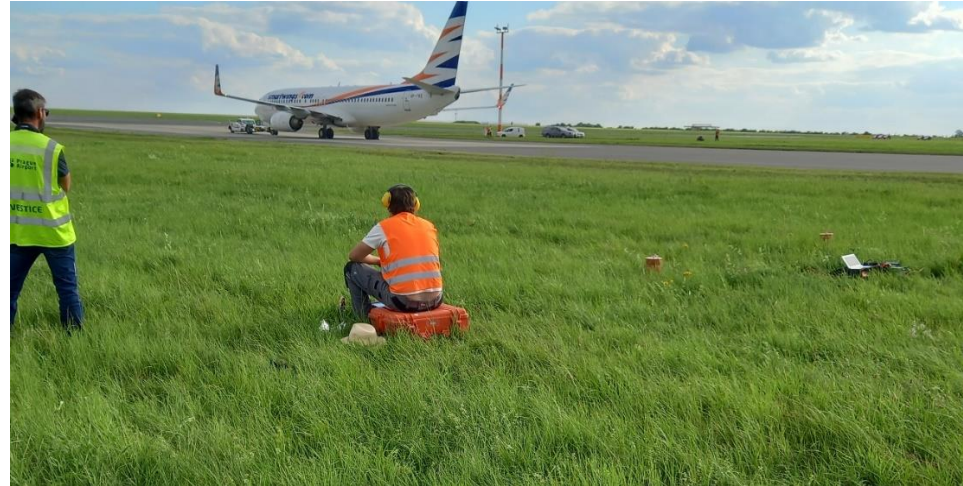
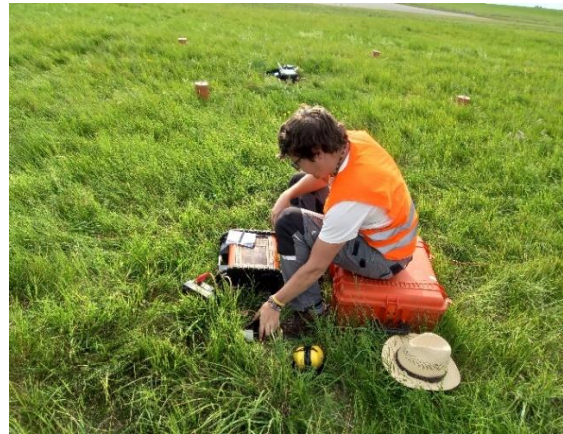
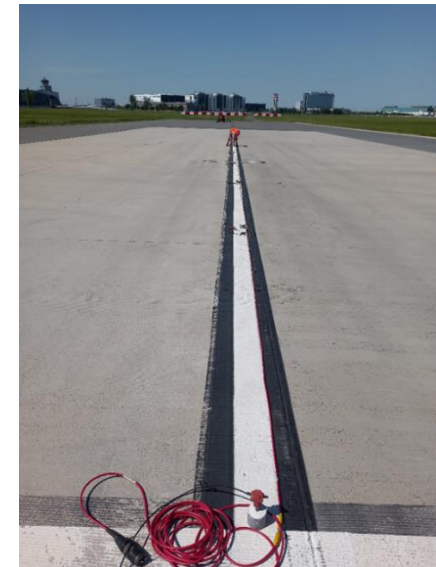
Fig. 6 Testing stand. Map of geophysical profiles (left on the top), testing airplane (right up), geophysical measurement (in the centre), layout with geophones (right on the below)

Profile 2, 24g

Seismic profile No. 2, 24 geophones, measurement in the process of engine test

Profile O

Seismic profile O, measurement before positioning airplane

- ★ Seismic equipment GIB
- ★ Seismic equipment GIA

The seismic equipment were setting in take consideration to safety regulation (see Fig. 6, map), out of protection strips. Since it was not possible to measure directly under the aircraft, the location of geophones (seismic sensors) was chosen so that we could estimate the maximum possible limit of seismic load close to the aircraft from partial knowledge.

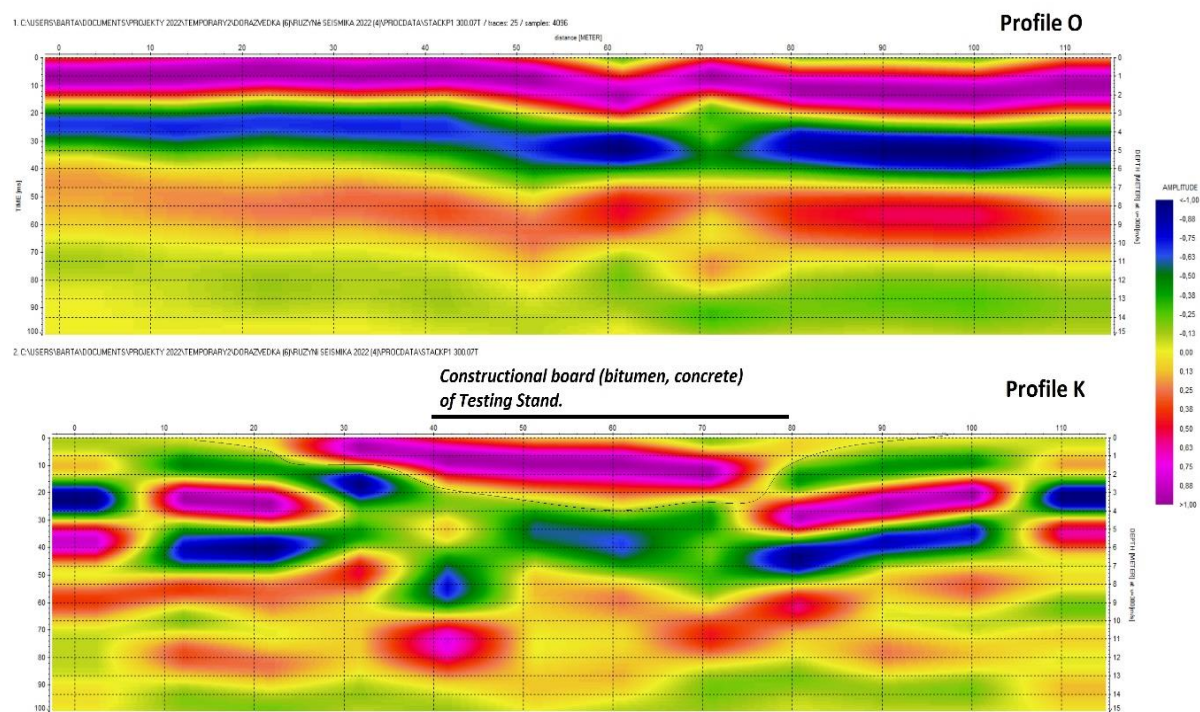
Fig. 7 Seismic reflection cross sections. Testing Stand. Profile O and K

The active seismic measurement (1st step of measurement on the Testing Stand) consists from one layout (profile O) which was situated on the lengthways axis of the runway and from the profile K, which was situated as perpendicular (see map on the Fig. 7). The seismic measurement verified a relative homogeneity of geotechnical conditions of the Testing Stand (see Fig, 7b) and enable an assessment of a damping of seismic waves (see Fig. 8).

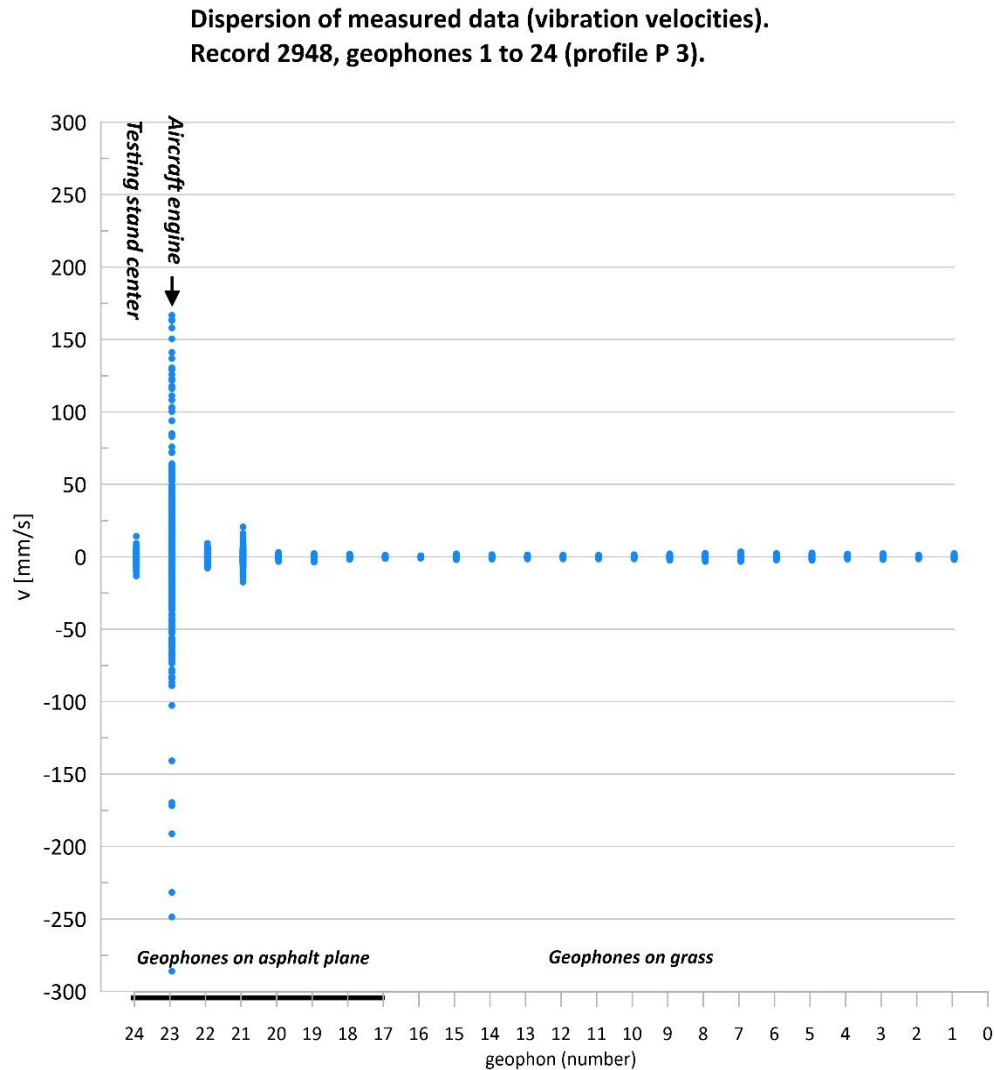
Fig. 11 Dispersion of vibration velocities, profile P3, 100% engine thrust

The Fig. 11 shows dispersion of vibration velocities from profile P3 in the situation with 100 % engine thrust. The horizontal axis presents the individual traces of geophones. The vertical axis presents values of velocities of vibrations. The graph contents all measured velocities detected with sampling time 0.250 msec. The graph is a proof of a reality that maximum vibrations are concentrates on the geophone (trace) No. 23 which is located right opposite behind the rocket engine. The vibrations is sharply moderated in the vicinity.

Peak particle velocity values reach extreme values only when measured in the extension of the longitudinal axis of the aircraft, i.e. frontally behind the aircraft engines. In our case, at a distance of 100 m from the aircraft on the P3 profile, values around $v = 170$ mm/s were measured. This can represent values around 2,550 mm/s when converted to the source location (for a very approximate estimate using conclusions on the attenuation coefficient, see Fig. 8). However, taking into account the scattering graph, see Fig. 11, it can be concluded that these extreme values are caused not by waves propagating through the rock environment, but by a pressure wave propagating through the air, and this wave penetrates the rock environment only minimally (this statement is based mainly on the analysis of Fig. 11 and the results of measurements at other sites). Under these circumstances, it can be expected that even with full operation on TWY L, the planned underground structures will not be endangered, provided that they are built in accordance with ČSN 730040 (Loading of buildings by technical seismicity and their response) according to Table 9, classification into class F (reinforced concrete and steel lining of metro tunnels and collectors, civil defence shelters). When moving aircraft on TWY L, it can be expected that the seismic waves

spreading through the rock will reach a maximum peak particle velocity in the order of units of mm/s, in extreme cases in the first tens of mm/s, The lowest dominant frequency is around 20 Hz. As part of the testing, the noise load was also measured. In the absence of the tested aircraft, an average value of 60 dB was measured. At full thrust of the motors of the tested airplane, a value of +130 dB was detected 30 meters from the motors.
