**A CASE STUDY OF THE GROUND-PENETRATING RADAR METHOD IN THE DIAGNOSIS
OF THE TECHNICAL CONDITION OF THE KOŠICE BRIDGE**

Abstract

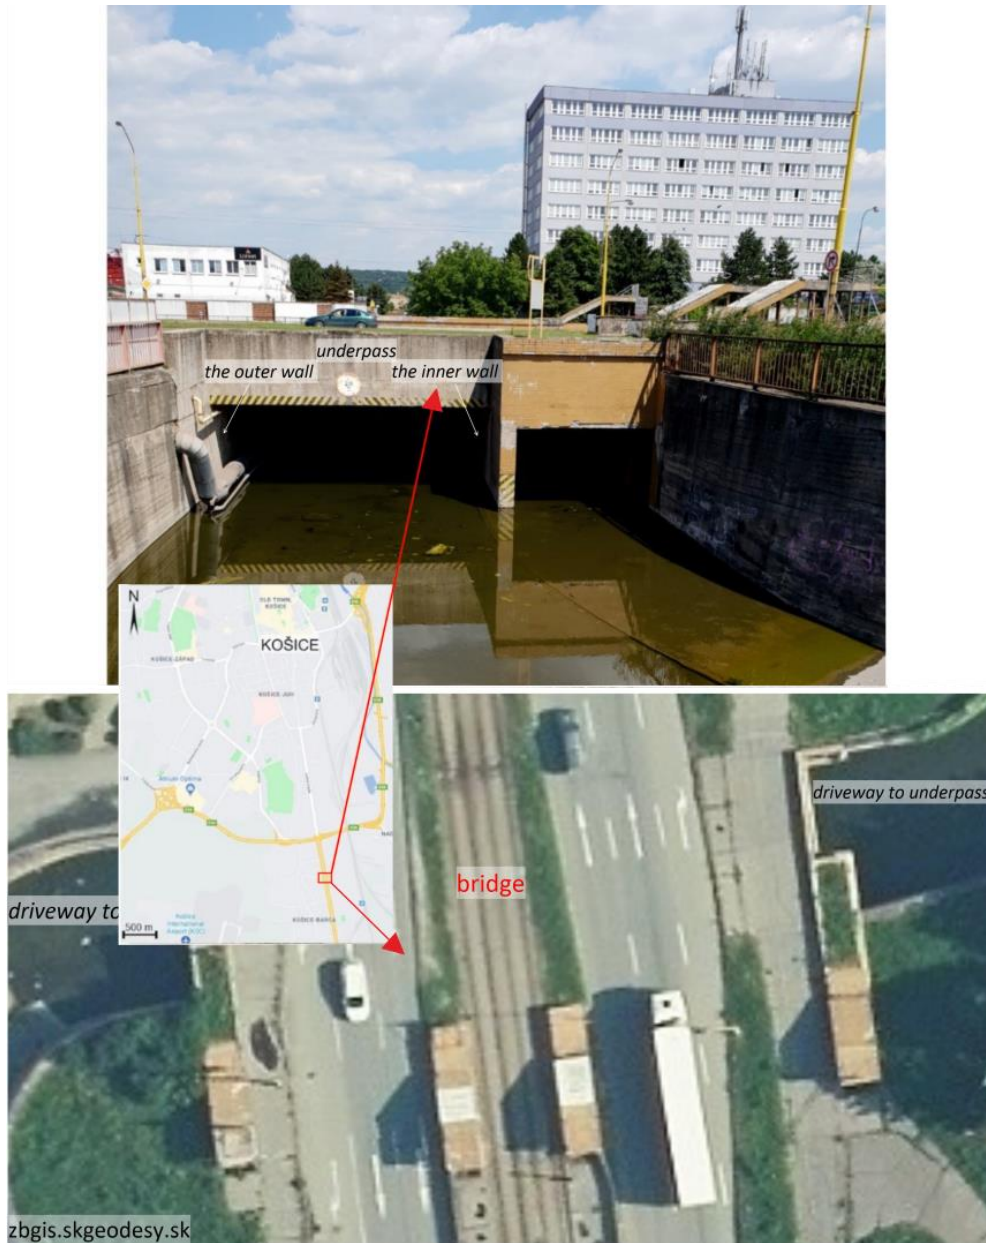
Fig. 1 The diagnosed object - a bridge with underpass to the ZŤS (VSS) in Košice

GPR measurements were also included in the comprehensive diagnostics of the technical condition of the bridge with an underpass in Košice (South-East of Slovakia). The diagnosed object is a bridge - underpass (Fig. 1). The self-diagnosis concerned the bridge deck, supporting structure, substructure (underpass) consisting of supports, pillars and wings, as well as sidewalks and railings. The main goal of the GPR measurements was to determine the thickness of structural layers and the state of waterproofing and to determine the thickness of the cover layer of the reinforcement. In addition, the compressive strength of concrete was determined by a non-destructive method (Schmidt's hammer), detection of interfaces with increased moisture by capacitive measurement of moisture and detection of seepage through waterproofing, measurement of the chloride content in the concrete surface layer of the concrete parapet, mapping of cracks and irregularities, detection of the condition of subsurface expansion joints and assessment of the condition of the track bed.

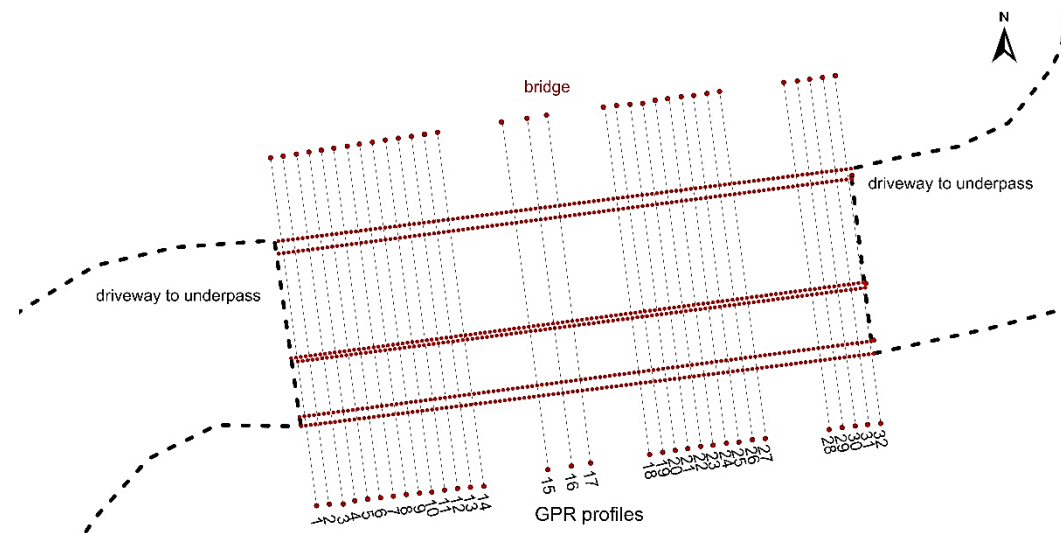
Fig. 2 Distribution of GPR measurement profiles on the bridge top

Profiles 1 to 4 and 28 to 32 are located on sidewalks (see Fig. 2). On profiles 28 to 32, there is considerable signal attenuation over the entire section of the bridge structure (distance 5.5 to 20 m). In this section, significant damage to the waterproofing is expected, which resulted in wetting of the structural layers of the bridge. The beginning and end of the bridge can be seen on the

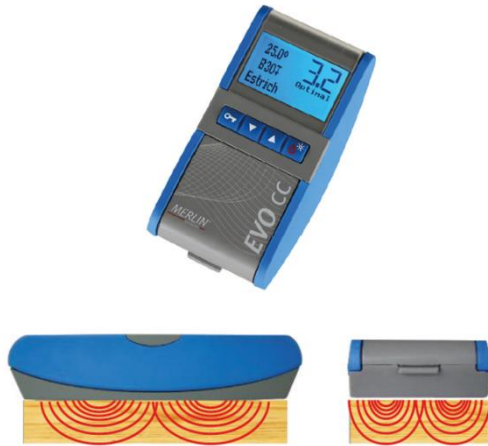
Fig. 4 Measuring device MERLIN EVO cc and the principle of capacitive humidity measurement

contact is placed on the construction sample. An alternating electric field that, depending on the shape, penetrates the sample to a greater or lesser depth (Fig. 4). The depth of penetration of the electric field of the capacitor into the measured material is between 2 and 5 cm. This depends on the shape and structure of the layer. The water contained in the building material has a substantial effect on the electric field. The changes in the field are therefore evaluated as water content.

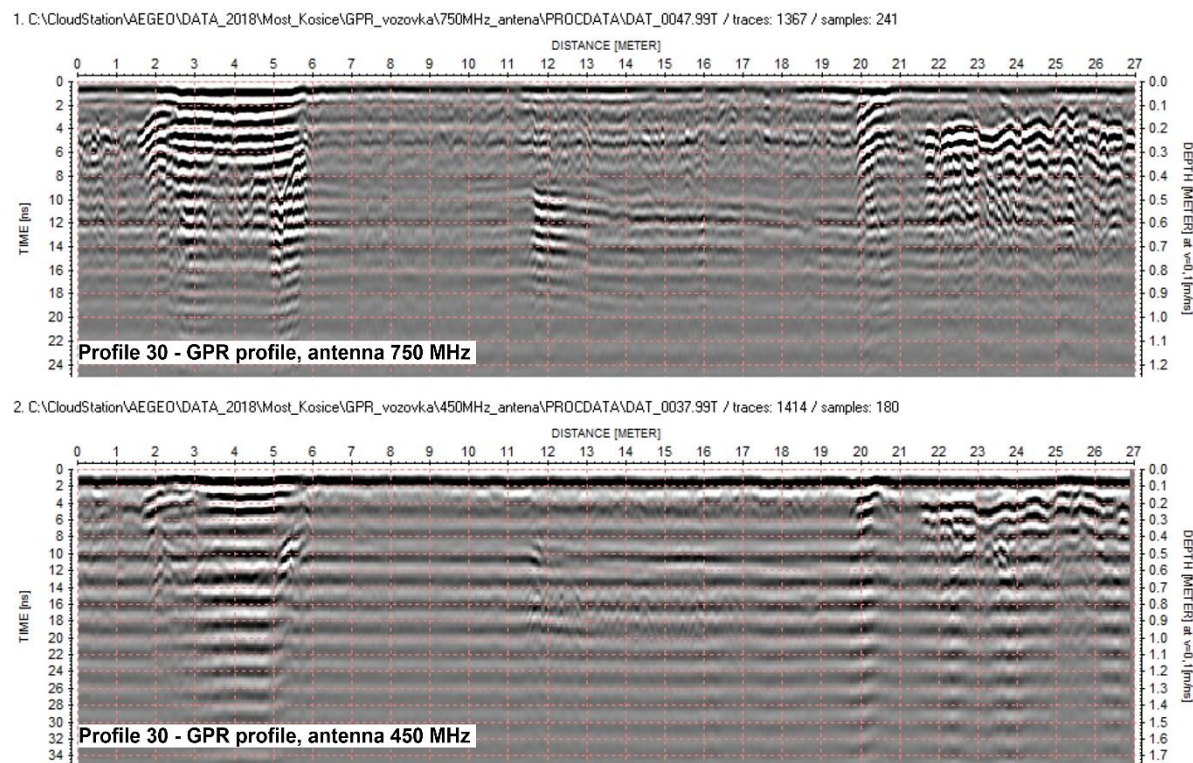
Fig. 6 Radargram on profile 30 – bridge top, footpath section. Attenuation of the signal in deeper parts caused by moisture indicates the damage of the waterproofing. The beginning and the end of the bridging, effects of the steel reinforcement are visible at a depth of approx. 70 cm.

radargrams, and on the sections from 12 to 16 m there are signs of steel reinforcement at a depth of 70 cm (Fig. 6). In the case of profiles 1 to 4, the expansion joints are located at 5.6 m and 20.8 m, but the information about the bridging is obscured by parallel utility networks.

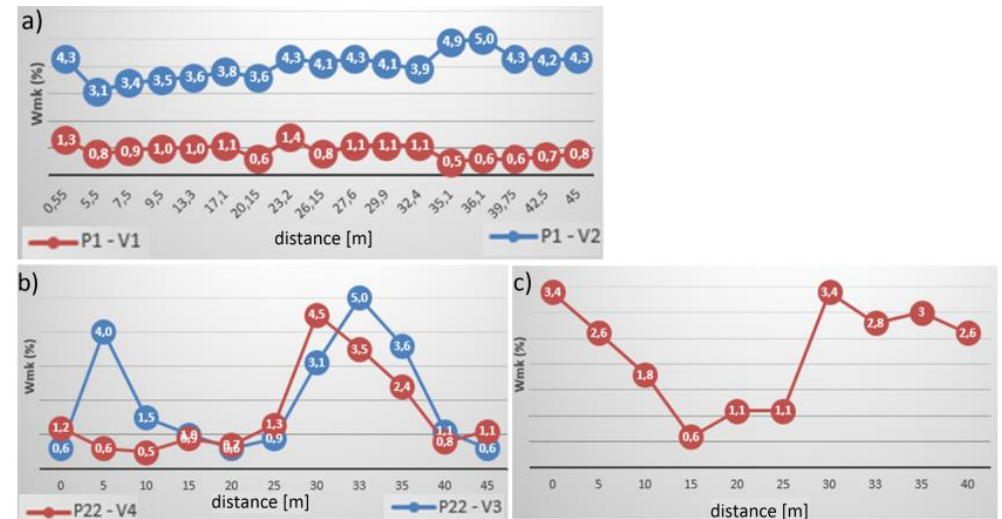
Fig. 13 Results of capacitive humidity measurement
a) Internal wall of the underpass. V1 – measurement in the lower part of the wall (110 cm above the road), V2 – measurement in the upper part of the wall (200 cm above the road)
b) The outer wall of the underpass. V3 – measurement in the lower part of the wall (110 cm above the road), V4 – measurement in the upper part of the wall (200 cm above the road)
c) Underpass ceiling

The measurements were processed into illustrative graphs in which the higher value represents a greater amount of water (Fig. 13).

The results of the capacitive measurement of humidity show that the concrete structure is significantly soaked in water. The inner wall absorbs water mainly in the lower part, the construction of which is below the water level. This fact is also proven in Fig. 14a, where the humidity increases from the ceiling downwards. The situation is different on the outer wall of the underpass, which absorbs water from the lower - flooded part of the underpass,

The ceiling of the underpass as well as the outer wall of the underpass have extremely high humidity in the second part of the profile starting at 25 m, which fits very well with the georadar results - profiles 18 to 27. In this part, we expect significant damage to the waterproofing and expansion joints.

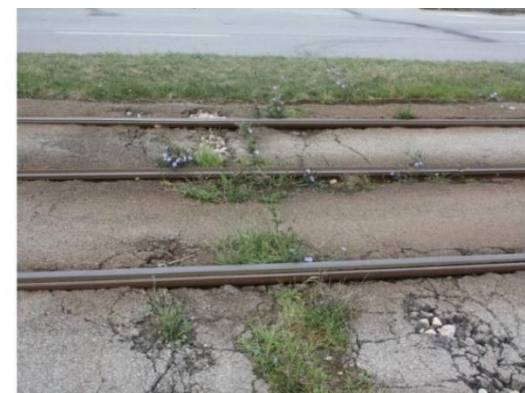
Fig. 15 Failure of the track bed

The problematic place of the track bed is the place where the tracks lead above the edge of the bridge from the city side - it is evident that the bed itself just next to the edge has settled and the tracks are partially in the air (Fig. 15) - the visible bends of the track have disturbed the asphalt concrete cover of the bed in the area of the tracks and the bends of the tracks when passing trams are visible to the naked eye (range approx. 1 - 2 cm).

The track bed is placed in a U-shaped reinforced concrete structure. The bed itself is (based on the visible aggregate grains) of relatively large fractions (approx. 63 mm), without significant content of smaller filling grains. The surface of the track bed is covered with a layer of asphalt concrete.
