**GPR DETECTION OF VOIDS UNDER CONCRETE COMMUNICATIONS (CASE STUDY)  
DETEKCE VOLNÝCH PROSTOR POD BETONOVÝMI KOMUNIKACEMI POMOCÍ GPR  
(PŘÍPADOVÁ STUDIE)**

**Abstract**

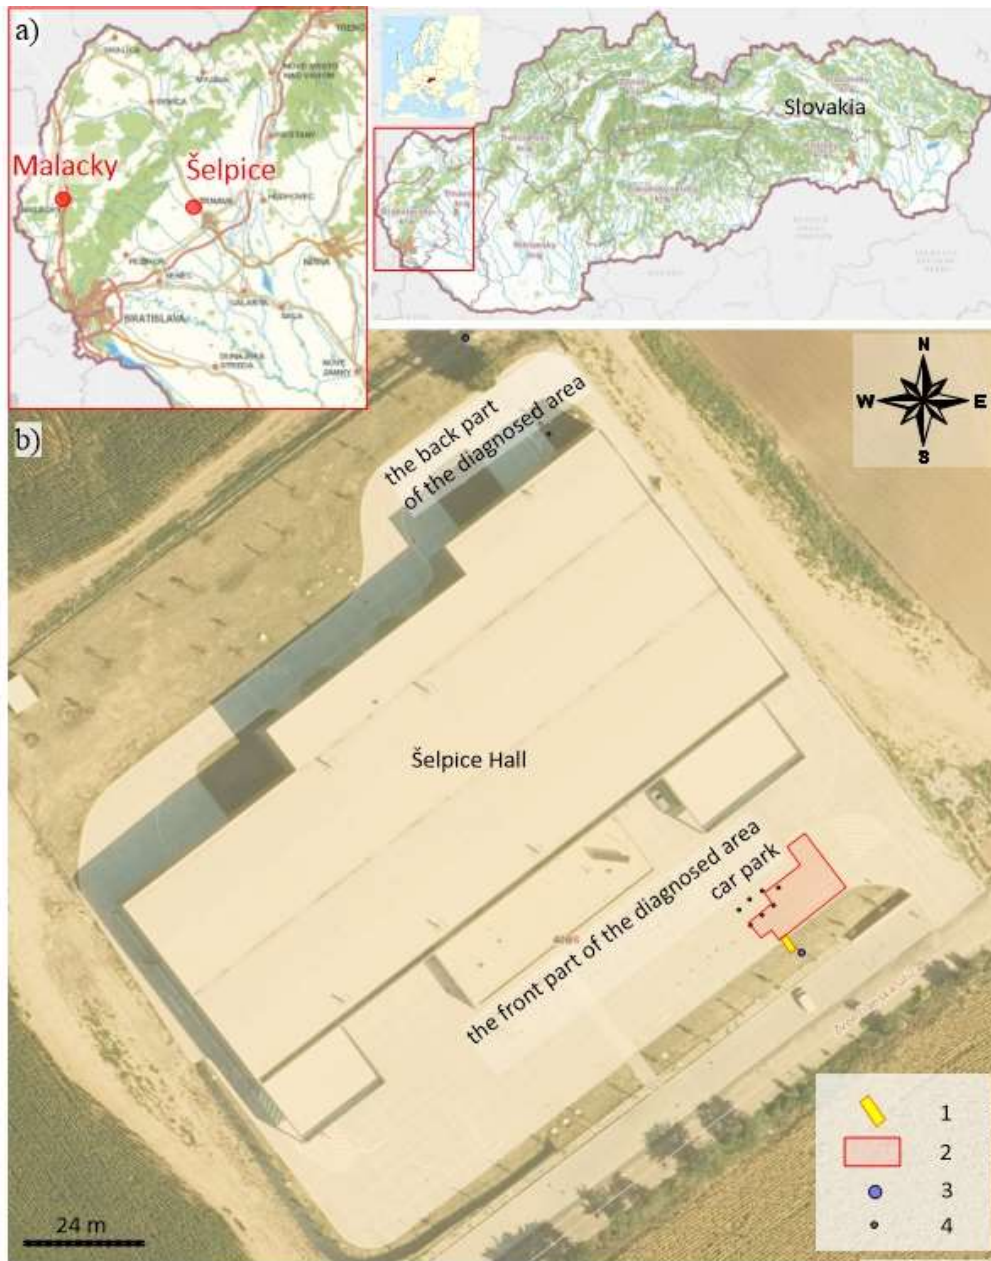
**Fig. 1 a) Localization of the areas of the presented case studies in the Slovak Republic. b) Area of the hall in Šelpice (source zbgis, ÚGKK SR, Bratislava); 1 - place of the parking lot curb and drainage channel damage, 2 - part of the parking lot where the concrete cover is removed, 3 - infiltration wells, 4 - retention tanks**

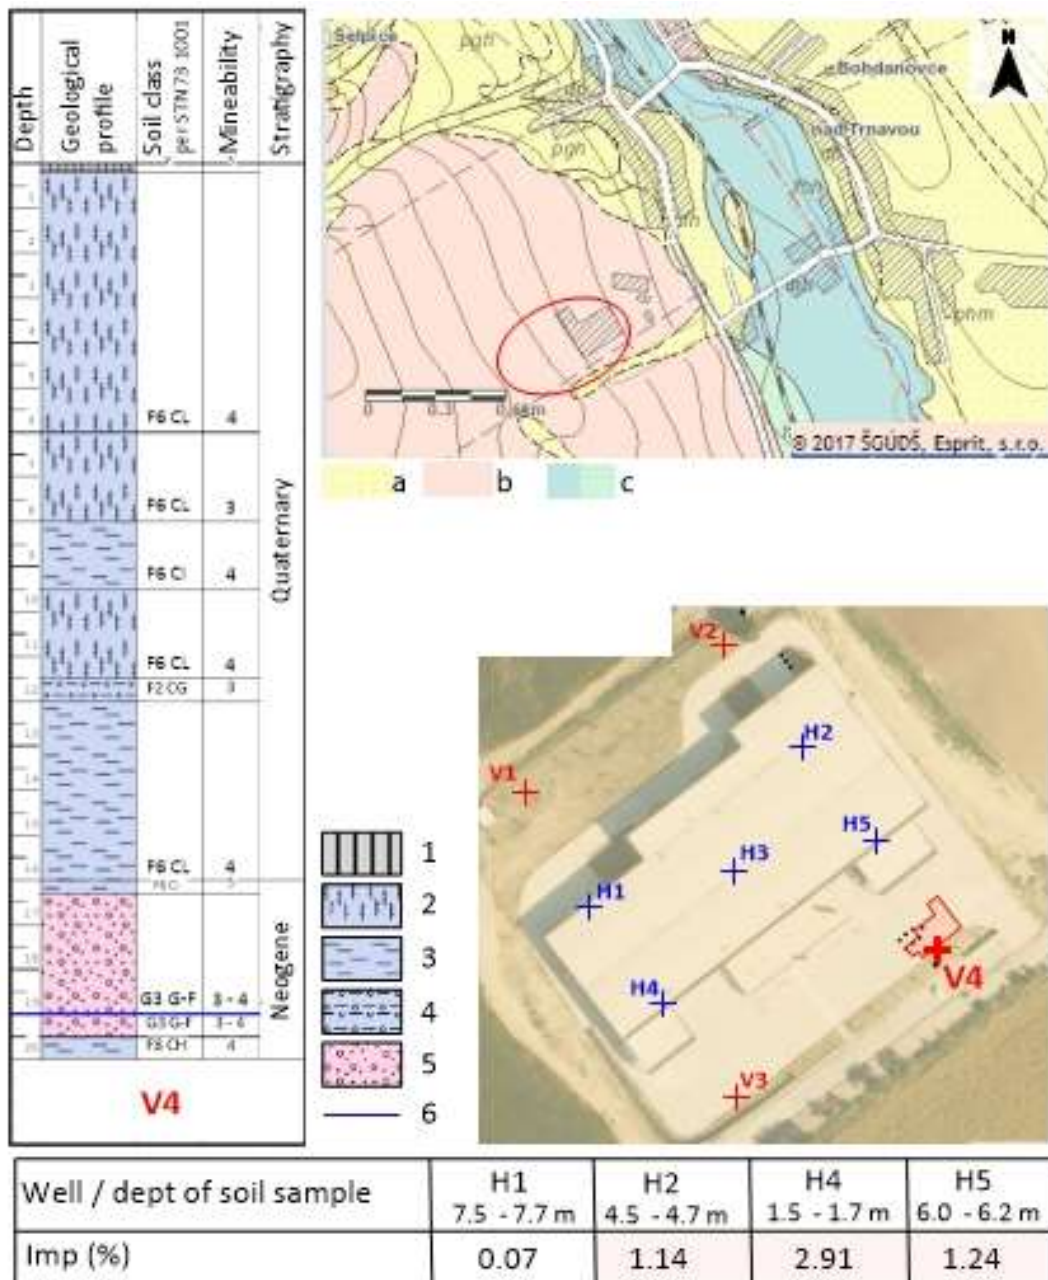
The task of the GPR measurements was to determine the extent and expansion of cavities in the area. However, for this it was necessary to know the cause of their formation. A more detailed study of the available materials (mainly exploratory boreholes carried out in this area) showed that the voids between the concrete panels and the underlying layers were created as a result of loess collapsibility under the underlying layers of the diagnosed building. The diagnosed areas of the hall complex in Šelpice are located in the Podunajská nížina (Danubian lowland), in the Trnavská pahorkatina (Trnava Upland) part. From a geological point of view, the pre-Neogene basement consists of crystalline rocks, on which Neogene marine sediments (reaching a thickness of up to 1000 m) and lacustrine-fluvial sediments are lying. However, from the point of view of the solved problem, Quaternary sediments are mainly interesting. In addition to fluvial-alluvial sediments linked to valley alluvial streams, large accumulations of loess are characteristic for the Trnava Upland area. These were also confirmed in boreholes (Fig. 3) realized during the engineering geological survey (Pavlech, 2018) before the start of construction. Based on the coefficient of collapsibility ( $I_{mp}$ ) determined on the samples from the wells, these loess horizons were classified as collapsible ( $I_{mp} > 1\%$ ), in one case even on the border of very collapsible ( $I_{mp} > 3\%$ ).

*Fig. 3 Geological conditions in the area of the diagnosed site in Šelpice; geological map (source: Digital geological map of the Slovak Republic), geological profile of the V4 well and the values of the coefficient of relative collapsibility ( $I_{mp}$ ) determined as part of the engineering geological survey (source Pavlech, 2018); a - proluvial sediments (rainy loams, sandy loams, clayey to sandy-loamy gravels, washed loess), b - eolian sediments (loess, loess clays, c) fluvial sediment, 1 - topsoil, 2 - loess, 3 - clay with an admixture of sand, CaCO<sub>3</sub> concretions, 4 - gravelly clay, 5 - gravel with an admixture of fine-grained soil, 6 - groundwater level*

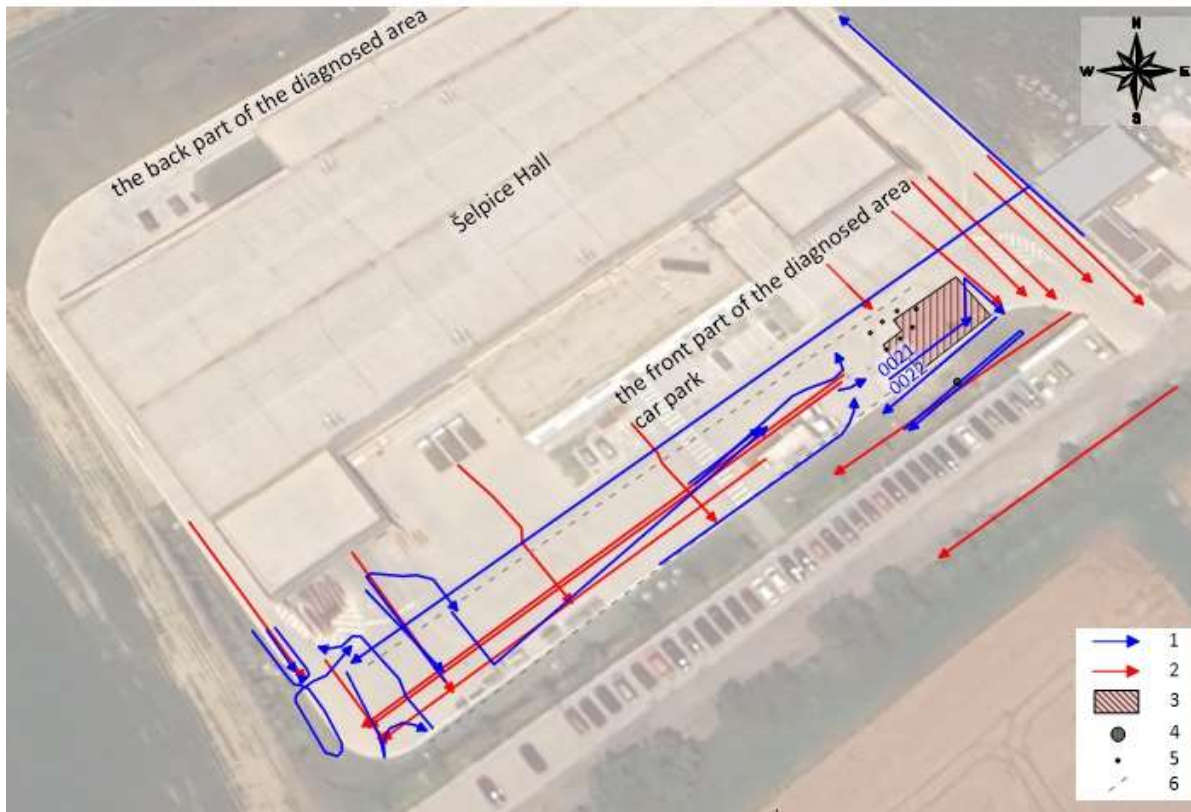
**Fig. 4** *The situation of the first stage of GPR measurements in the area in Šelpice: 1 - GPR profiles measured with a 450 MHz antenna, 2 - GPR profiles measured with a 160 MHz antenna, 3 - the area of the removed concrete cover of the parking lot, 4 - a seepage well, 5 - retention tanks, 6 - drainage channels*

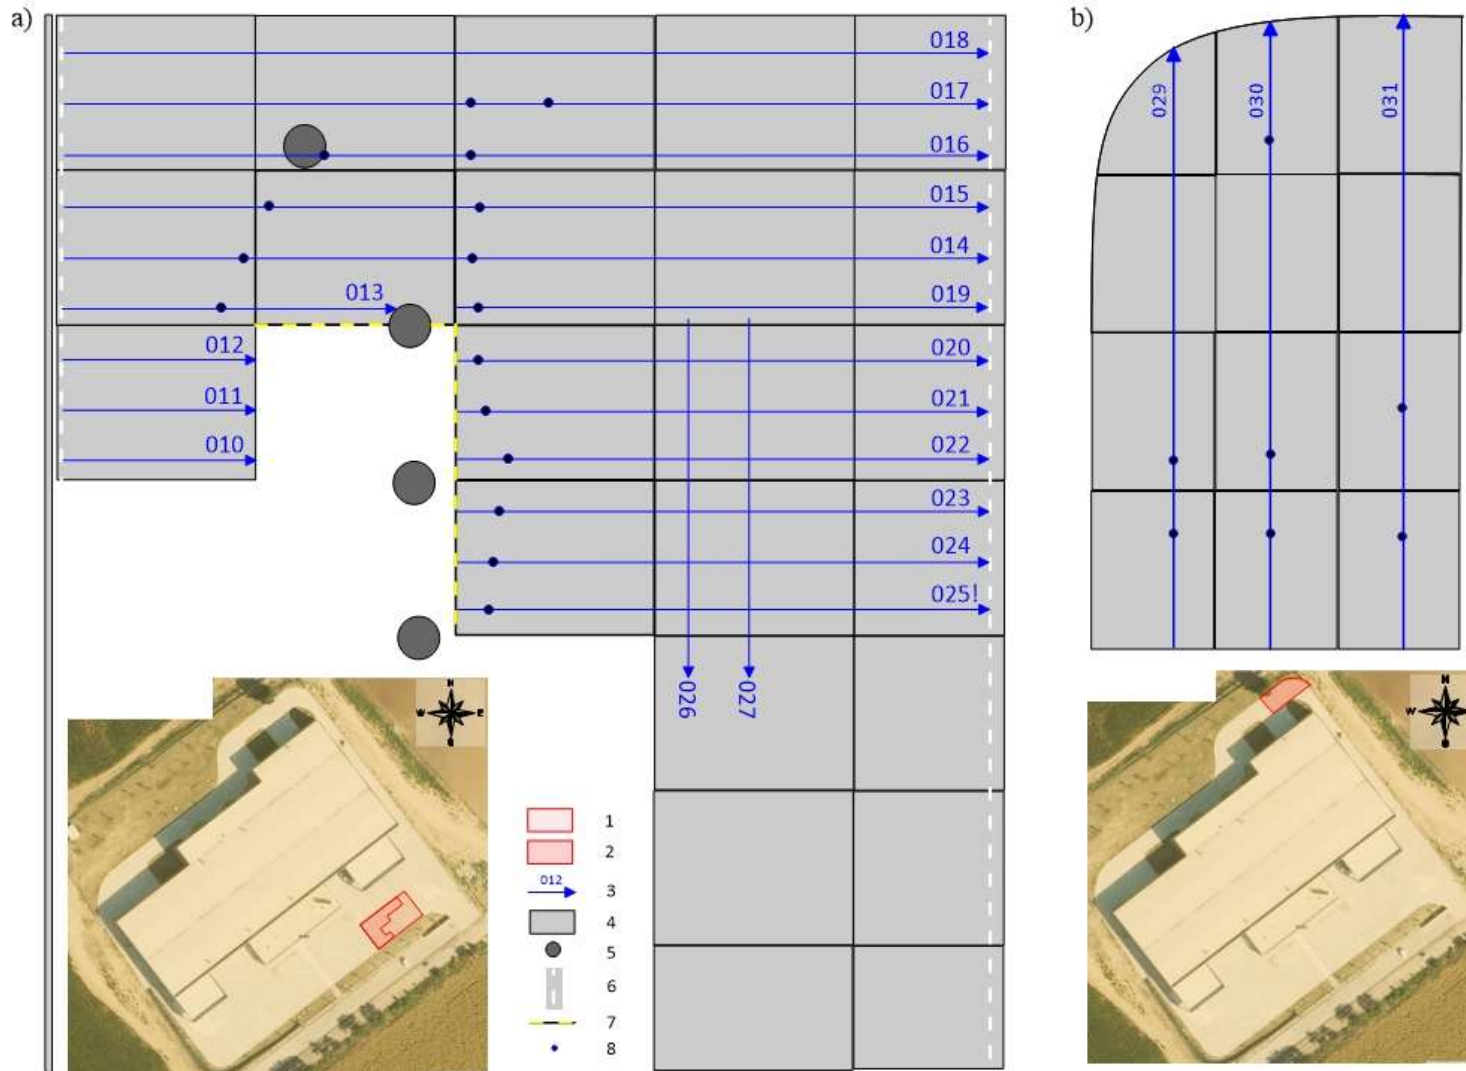
*Fig. 5 Situation of the second stage of GPR measurements of the area in Šelpice: a) front part of the parking lot, b) backside of the area; 1 - area with removed concrete cover, 2 - area of GPR measurements with a 1.6 GHz antenna, 3 - GPR profile, 5 - concrete plates of the parking lot/roadway cover, 5 - covers of retention tanks, 6 - drainage gutters, 7 - places with visible continuation of the cavities under the parking lot cover, 8 - marking of the expansion of the cavity*

Based on these anomalous manifestations on the radargrams, the spatial occurrence of the cavity was marked directly in the field during the measurement (Fig. 5a).

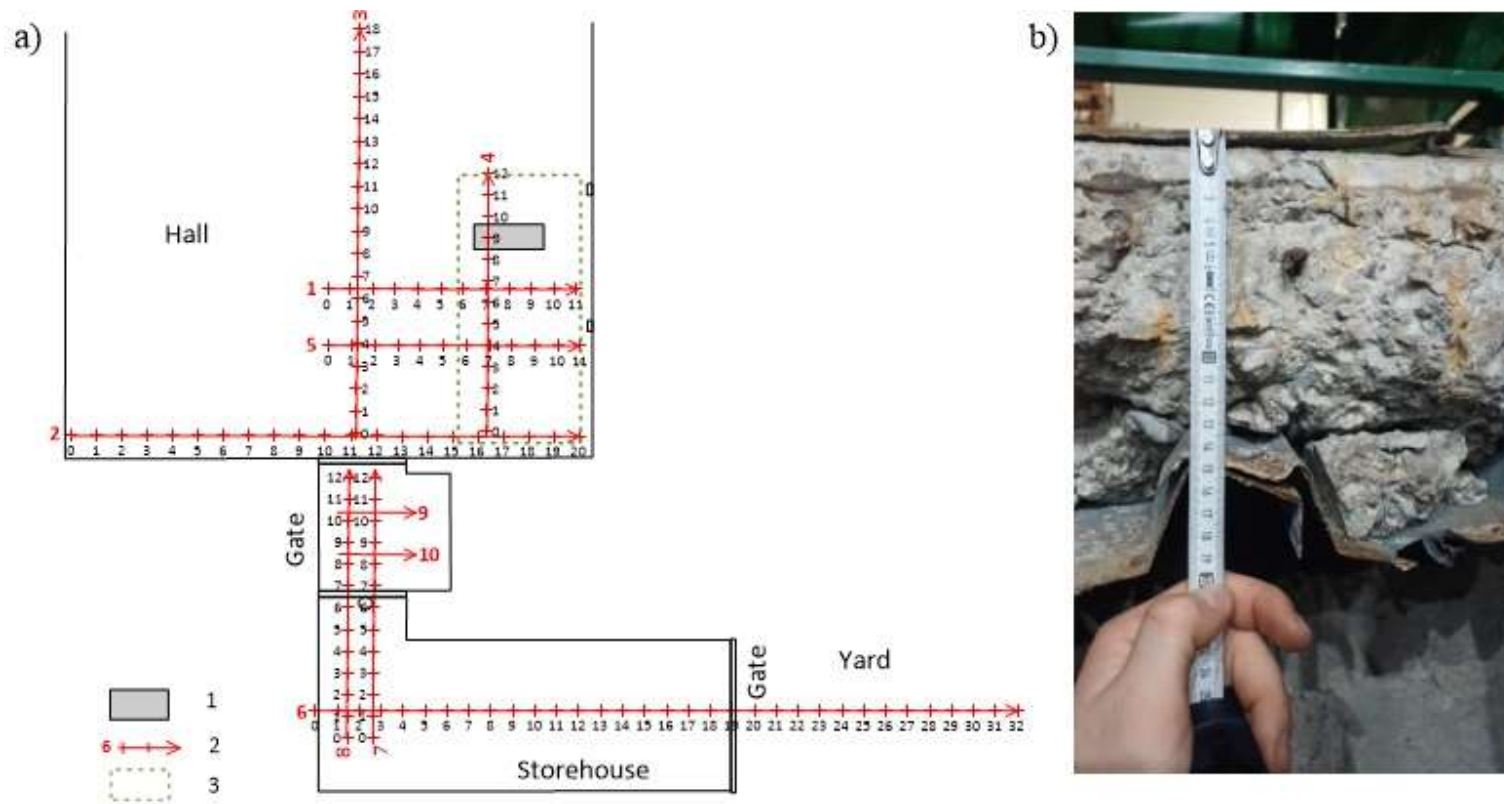
*Fig. 6 a) Situation of GPR measurements in the hall in Malacky; 1 - inspection hole in the floor of the hall above the hollow spaces, 2 - GPR profiles with meterage, 3 - area of trapezoidal sheet manifestations on the interpreted radargrams. b) side view of the floor construction with a trapezoidal sheet in the inspection hole*

Underground spaces did not appear directly on the radargrams. The presence of a trapezoidal sheet in the floor above the underground spaces caused an increased attenuation of the signal, and the GPR did not record any other interface below this surface. However, the radargrams clearly showed the presence of two structural types of floors in the hall, as can be seen on profile 1 in fig. 11. Profile 1 passes through both types of floors. In the first part of the profile (up to approx. 5.8 m), the rebar reinforcement of the first type of floor (depth approx. 0.18 m) is displayed on the radargram. Below it, at a depth of approx. 0.3 m, there is an interface between the concrete and the embankment. No heterogeneities were detected in the layer below the concrete that could indicate the presence of voids. The situation is different in the second part of the profile (from 5.8 m to 11 m), which passes close to the inspection hole. At a depth of 0.15 m to 0.21 m, the trapezoidal sheet of the second type of floor and the subsequent attenuation below it are captured on the radargrams. The extent of the underground spaces under the floor of the hall was thus determined based on the manifestation of the second type of floor construction with trapezoidal sheet metal (Fig. 6). Both types of floors were also captured on the radargrams of profiles 2 and 5. Profile 4 leads directly through the inspection hole and passes through the floor with a trapezoidal sheet in its entire length. On profile 3, only the rebar reinforcement of the first-floor type was present.

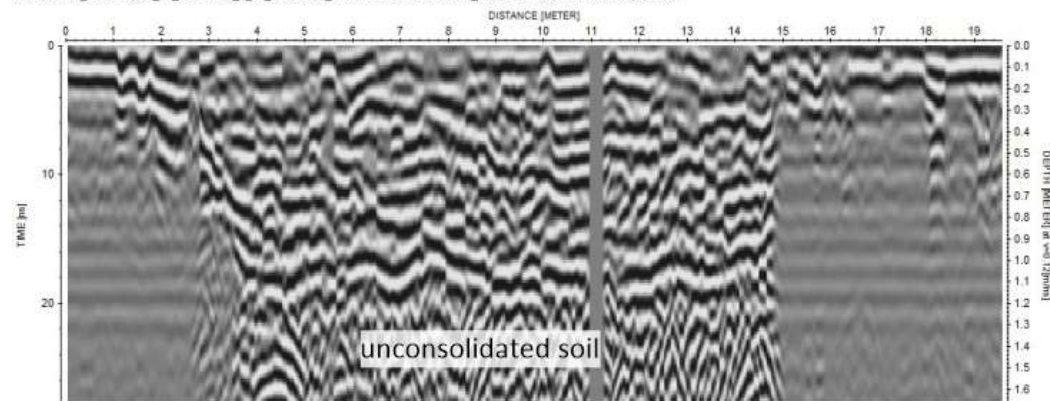
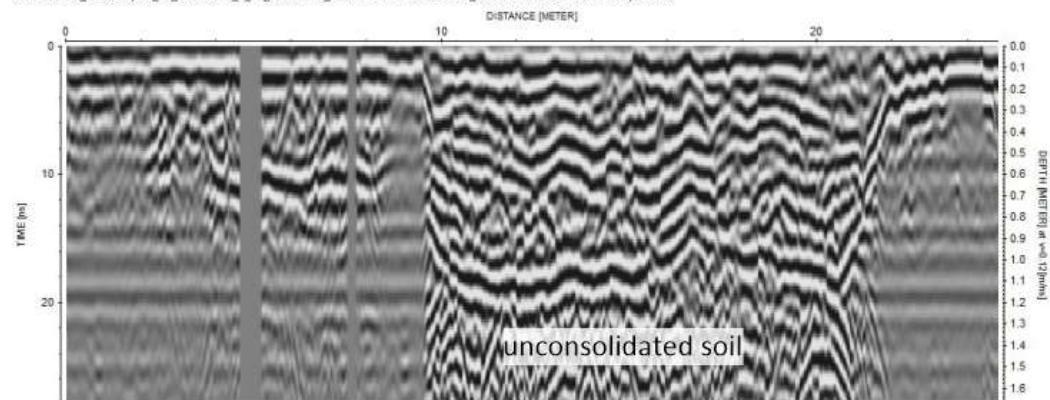
Measurements from the first stage of the survey did not show the presence of voids or other significant deformations of the basement at greater depths (up to 1.6 m with a 450 MHz antenna, up to 12 m with a 160 MHz antenna), except in the area where the retention tanks are installed. On the radargrams measured in their vicinity with a 450 MHz antenna (Fig. 7), when compared with the recording from other parts of the measured area, the environment here is inhomogeneous and that the return embankment in these places is not consolidated. The

result of the first stage was the finding that the occurrence of the cavity exposed in the front part of the parking lot is probably linked to the area around the retention tanks, while their formation occurred as a result of loess collapsibility in their basement.

**Fig. 7: Examples of processed radargrams measured by the 450 MHz antenna in Šelpice during the first stage**
